## NO GALLING OBSERVED WITH EXPANITEPURELOW-T TREATMENT ON EN 1.4404 (AISI 316L)

### Standard Test Method for Galling Resistance of Materials (ASTM G98)

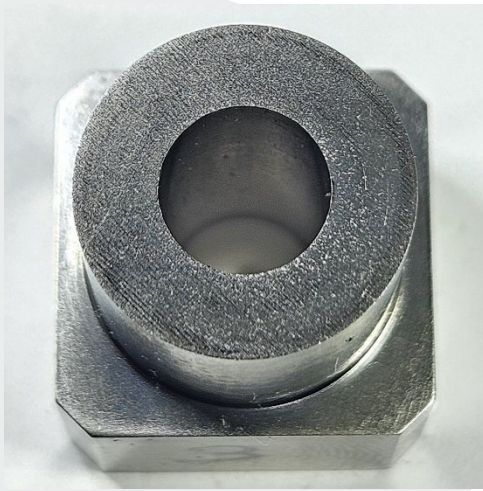
**Figure 4:**  
Top: surface of a button after test. Bottom: surface of a block after test. Tested at 30ksi.

All test pieces have been photographed. The surfaces of samples tested at the lowest and highest load are shown in Figures 4 and 5. Almost no signs of test related surface deterioration are visible on the button tested at 30ksi, some burnishing or flattening of roughness seen as increase in surface shine is noticeable. The mated block shows signs of wear and minimal scoring. For the button tested at 80ksi some wear can be seen, however its test counterpart shows quite extensive scoring on the edges of the mark left by the button, mostly due to the yield strength of the underlying material being significantly lower than the test load. Over 500MPa of normal force was not enough to induce serious deterioration of surface during the test. The calculated minimal increase of test pressure required to achieve galling on the ExpanitePureLow-T treated samples is at least 400 times that of the untreated EN 1.4404. Unfortunately, due to the limitations of the test setup, we were unable to determine the exact value.

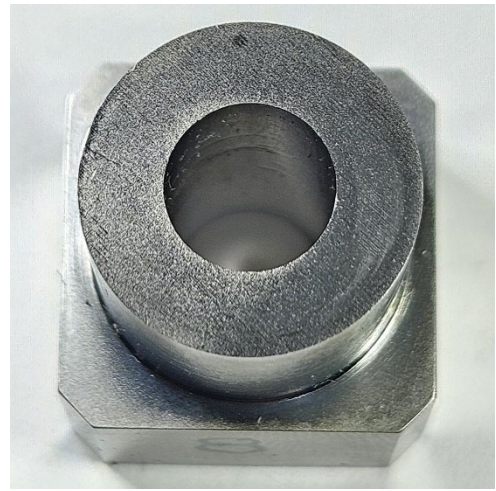
**Figure 5:**  
Top: surface of a button after test. Bottom: surface of a block after test. Tested at 80ksi.
